Docket No. 217 – Development and Management Plan Inspection

Northeast Utilities Service Company Certificate of Environmental Compatibility and Public Need for the construction of a 345-kV electric transmission line and reconstruction of an existing 115-kV electric transmission line between Connecticut Light and Power Company's Plumtree Substation in Bethel, through the towns of Redding, Weston, and Wilton, and to the Norwalk Substation in Norwalk, Connecticut.

Date: October 25, 2006

Inspector: Diana Walden, BSC Group

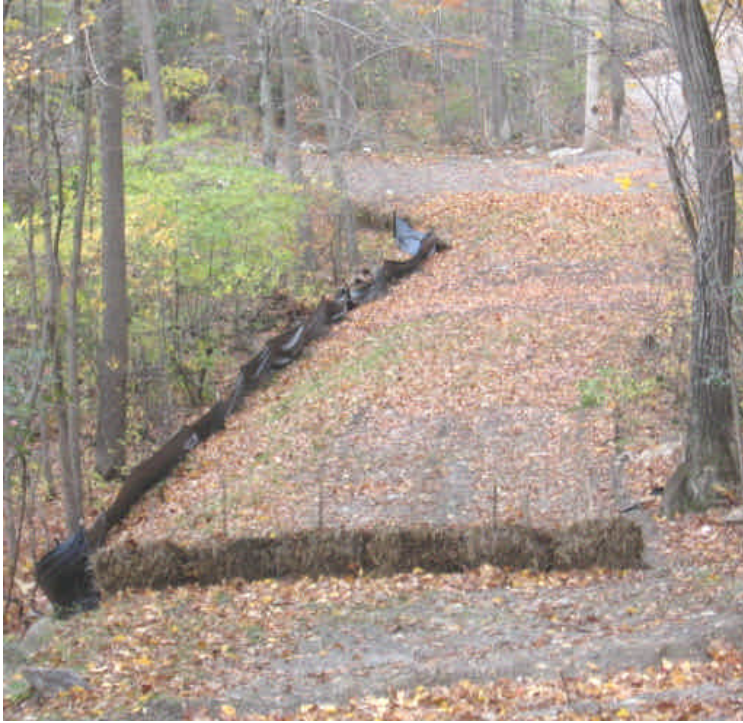
(Composite Section): Photo on the left shows the access road leading past Archers Lane with haybales in place and some grass growth noted. (345kV H-Frame): Photo on the right shows mats remaining at the stream crossing off Webb Rd. in the Bethel Reservoir section. 10/25/06.

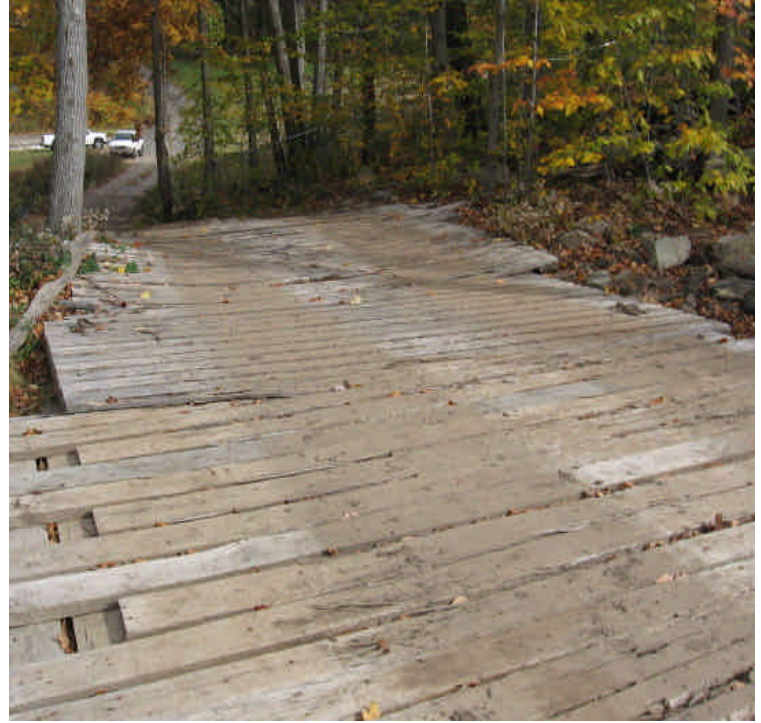
345kV H-Frame	<p>- Mats remain at the stream crossing off Webb Road, in the Bethel</p>	<p>- Silt fence should be replaced with haybales in appropriate locations.</p>	<p>- Continue final restoration.</p>

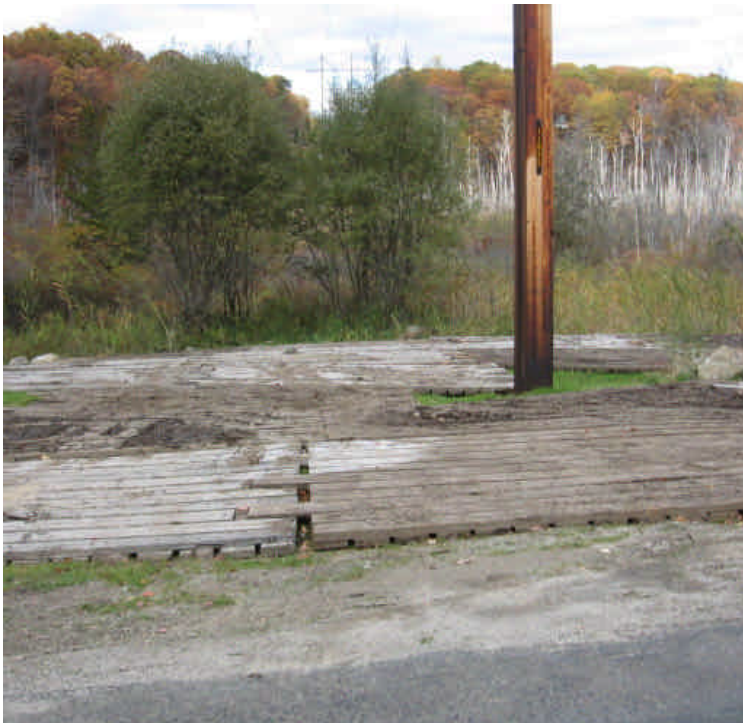
- Mats and disturbed soil were now present at the previously restored area near structure #25. 10/25/06.	- Remove mats and re-stabilize the area. Silt fence should now remain here until this occurs. 10/25/06.	-Needs attention.
	-The slopes associated with the stone access road at structure #24 do not appear to be stable. Loose stone could wash into the wetland once silt fence is removed. 10/18-10/25/06.	-Investigate further stabilization measures for the slopes adjacent to the wetland. 10/18-10/25/06.	-Needs evaluation.

(345kV H-Frame): Photo on the left shows the area at pole #25 where mats and disturbed soil are now present on the previously restored area. Silt fence should now remain in place due to the additional disturbance. **(Norwalk Section):** Photo on the right shows mats remaining at the wetland crossings at Kent Rd south. 10/25/06.

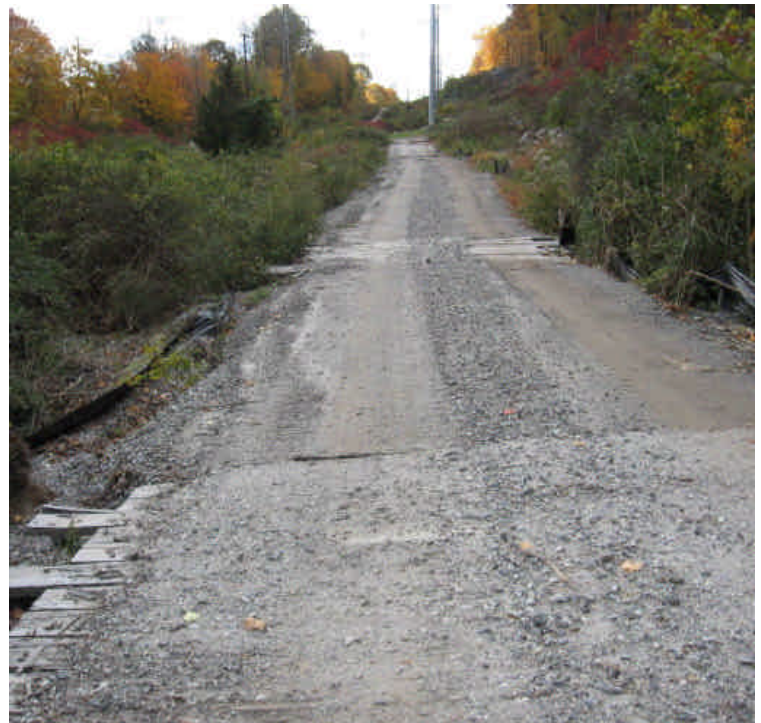
Kent Rd. (South)	<p>- The work areas at Kent Road (south) have been restored with grass cover in most locations but mats still need to be removed. 9/29-10/25/06.</p> <p>- Stone from the access road continues to washout beyond the erosion controls into the wetland. Silt fence/ haybales here are deteriorating. 9/29-10/25/06.</p>	<p>-Monitor until mats have been removed and the access road is stable. 10/25/06.</p> <p>- Stabilization options for the stone access road should be evaluated. 920-10/25/06. These areas will be difficult to control during heavy rain due to the drainage patterns. 7/12-10/25/06.</p>	<p>-Needs attention</p> <p>-Needs attention</p>
Inland Wetland and Watercourse encroachment and mitigation	<p>-The wetland crossing near structure #34 off Gallows Hill Rd has been removed.</p>	<p>- Monitor the hydrology within the crossing to be sure this area continues to function properly. 10/18-10/25/06.</p>	<p>-The crossing was removed.</p>

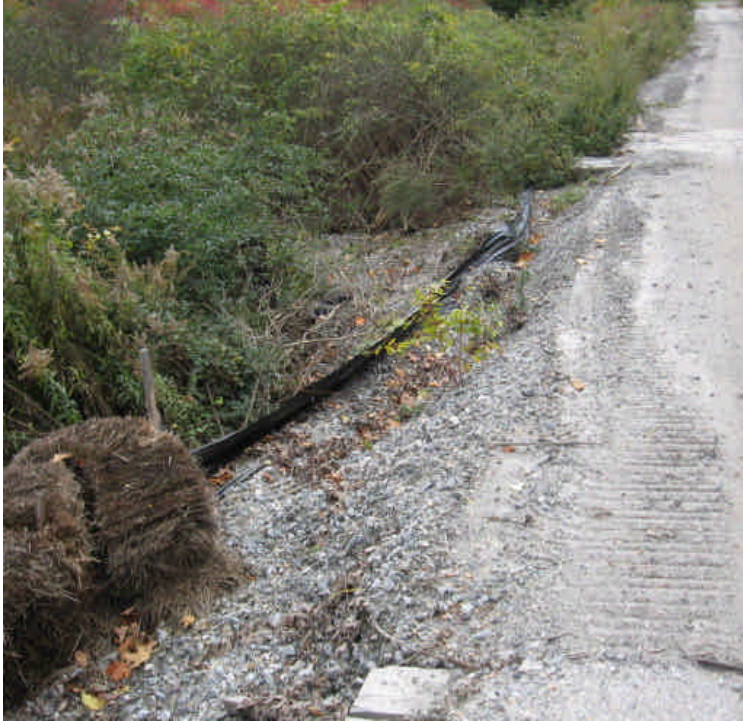
Photo on the left shows a close up of one of the several washout areas along the access road on Kent Rd south. Photo on the right shows restoration efforts at Kent Rd north. Work areas were mulched. Some debris and equipment remains to be removed from site. 10/25/06

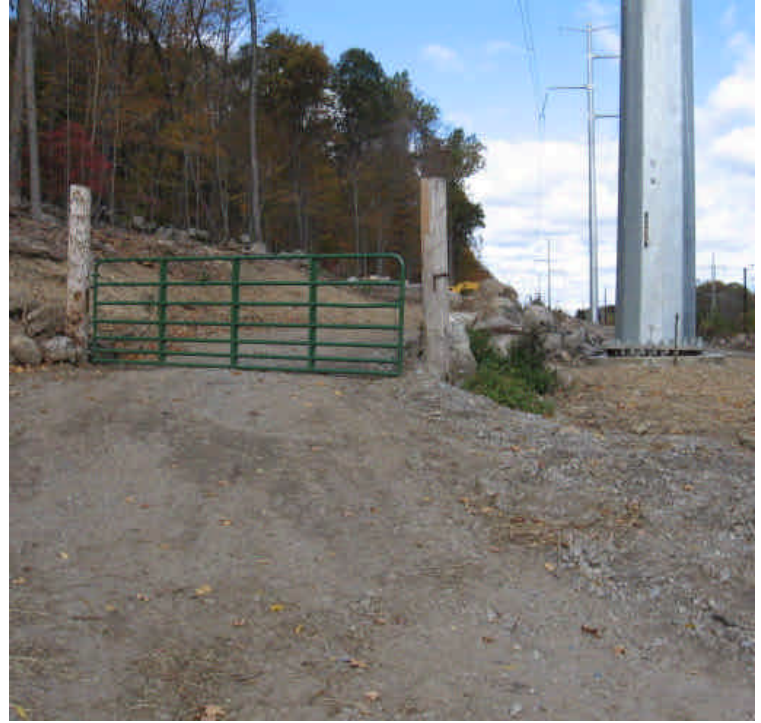
Areas of Inspection	Observation	Recommended Action	Corrective Action
Kent Rd. (North)	<p>in the soil along Broad St adjacent to the bike path. Silt fence also remains in place within the vegetation near the river. 10/25/06</p> <p>- Restoration activities have continued at Kent Road north. Most of the disturbed areas within the ROW have been mulched and temporarily stabilized. A portion of the stream crossing remains but other mats were removed. 10/25/06.</p> <p>- Silt fence was removed from the banks of the stream and near the foundation at the pond in the Kent Rd north section. The areas were mulched. 10/25/06.</p>	<p>-Continue restoration efforts and return as near as possible to original conditions. Haybales may be needed adjacent to standing water to prevent sedimentation from the mat removal area. 10/25/06.</p> <p>-Areas appear temporarily stabilized but no further vegetative cove is expected prior to winter. 10/25/06.</p>	<p>feasible.</p> <p>-Restoration efforts are noted.</p> <p>-Silt fence was removed; areas were mulched</p>

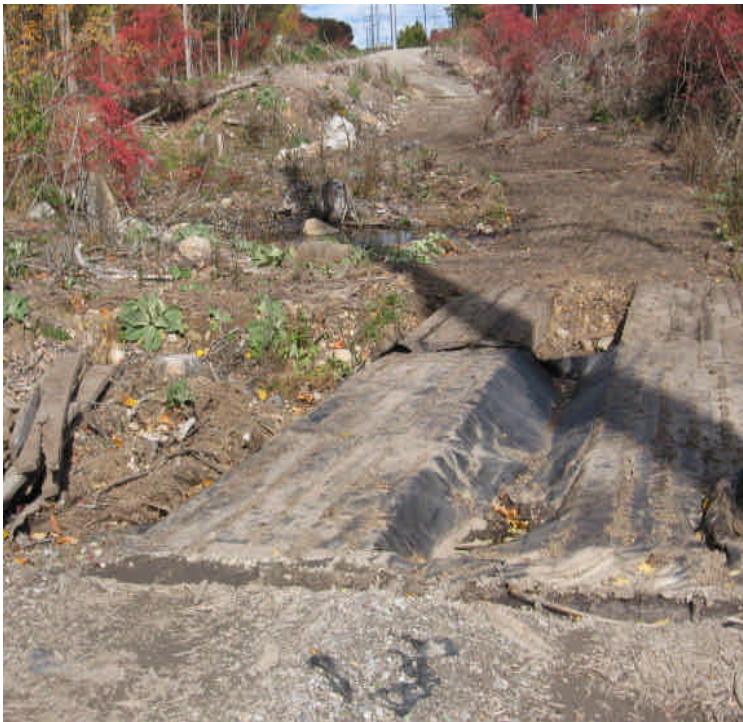
Photo on the left shows the remaining crossing materials on the currently dry stream channel in the Kent Rd north section. Mats were removed but some pieces remain to be removed. Photo on the right shows a view of the area where mats had been removed. 10/25/06.

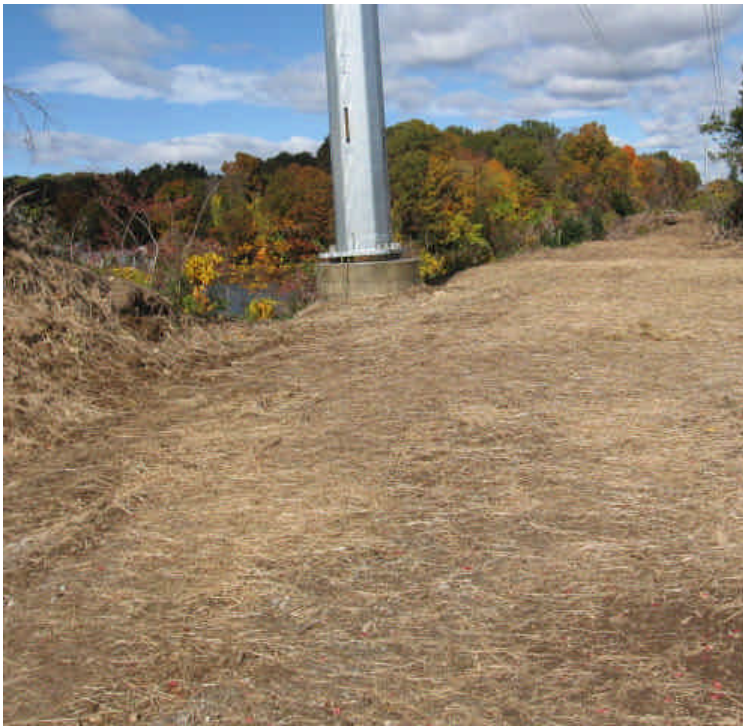
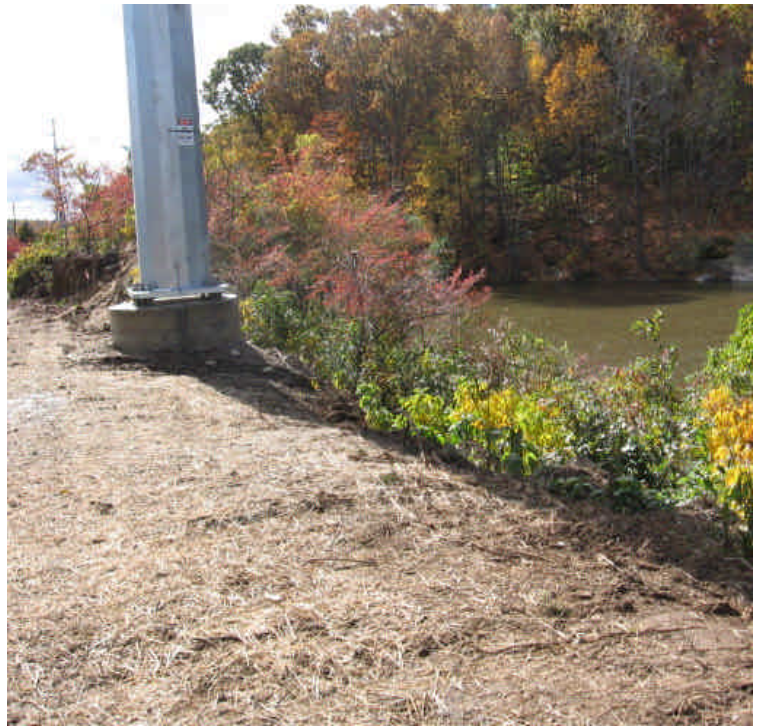
Both photos show restored areas along the access road and above the bank of the pond in the Kent Rd. north section of the ROW. Areas are temporarily stabilized and silt fence was removed. A buffer of vegetation remains between the restored areas and the pond. 10/25/06.

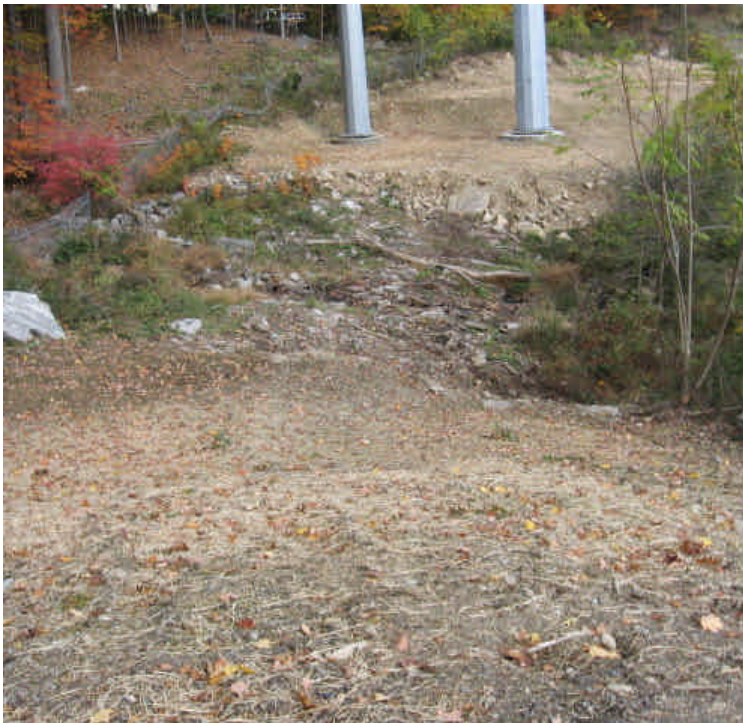
Photo on the left shows the mulched slopes near structure #64 off North Seir Hill Rd. Haybales should still be installed along the base of the slopes to prevent sedimentation to the stream here. Photo on the right shows the small washout overwhelming the silt fence at structure #1180. The adjacent areas have some grass cover. 10/25/06.

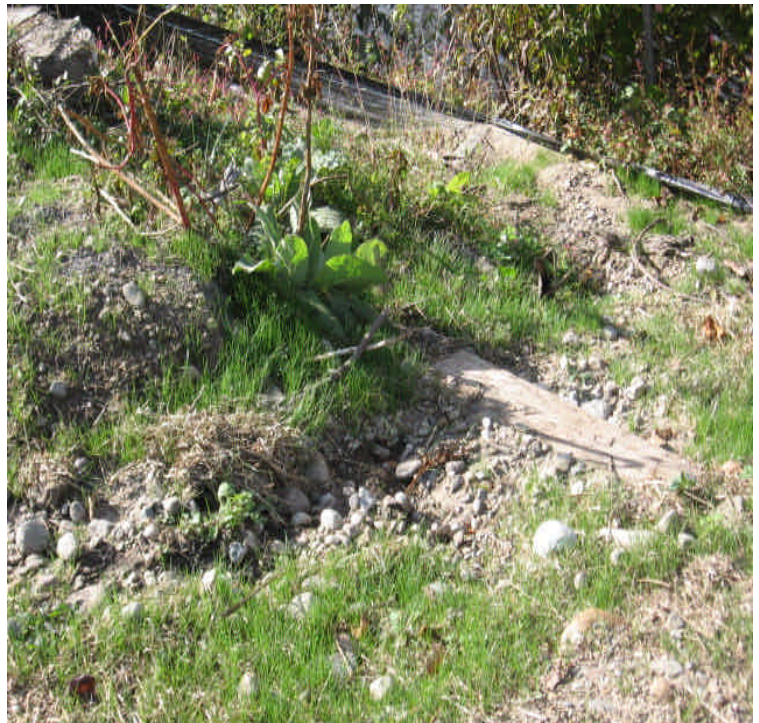
- Grass growth was noted at structure #11080, off Broad Street south, but washouts in the mulch continue. The silt fence here is stressed. 10/04-10/25/06	- Repair silt fence and monitor. Further grass cover is not expected prior to the winter. 10/4-10/25/06.	- Restoration was noted but still needs attention
	-Silt fence debris remains	- Remaining silt fence and debris should be removed. 10/25/06	- Needs attention when
